Test Report

No.: SDHG1509014615FT

Sample Description : ALLOY CHAIR FOOT
Style / Item No. : A403
Sample Receiving Date : Sep.02, 2015
Test Performing Date : Sep.02, 2015 to Sep.09, 2015

Test(s) Requested	Result(s)
Clause 7 of ANSI/BIFMA X5.1:2011	PASS

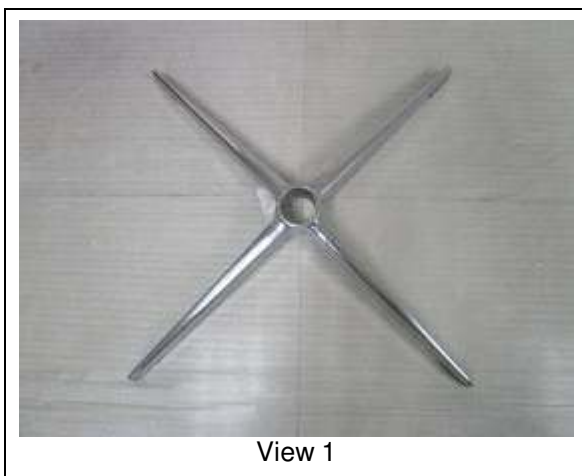
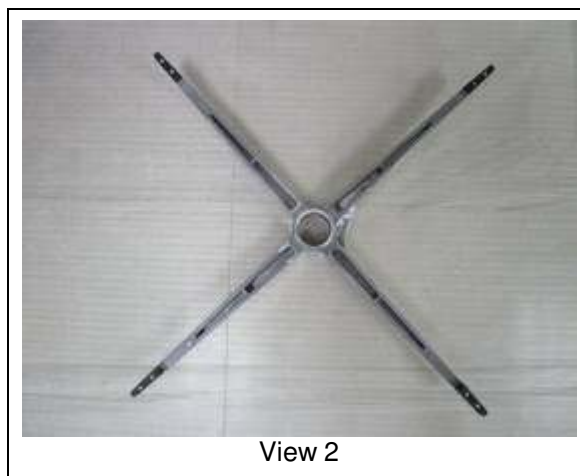
Sample as Received

Weight: 1.48kg

Base Radius: 330mm

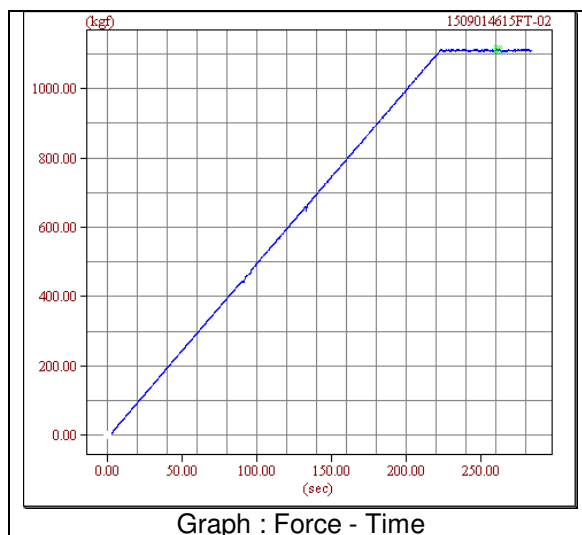
Test Pictures with Details

Test Clause	Test Description and Requirements	Test Results
7	Base Test – Static There shall be no sudden and major change in the structural integrity of the base. The center column may not touch the test platform during the load applications when a force of 11,120 N (2500 lbf.) is applied to the vertical support column, or test fixture that simulates the taper/base interface for one (1) minute. Remove the force, and then apply a second force of 11,120 N (2500 lbf.) for one (1) minute.	PASS
