**Test Report** No.: SDHG1509014612FT Date: Sep.10, 2015 Page 1 of 3

Sample Description : ALLOY CHAIR FOOT

Style / Item No. : A503

**Test Result Summary**

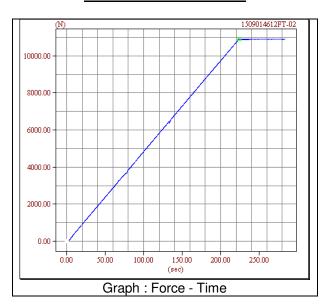
### **Test Pictures with Details**

| Test Clause | Test Description and Requirements | Test Results |
|---|--|---|
| 7 | Base Test – Static There shall be no sudden and major change in the structural integrity of the base. The center column may not touch the test platform during the load applications when a force of 11,120 N (2500 lbf.) is applied to the vertical support column, or test fixture that simulates the taper/base interface for one (1) minute. Remove the force, and then apply a second force of 11,120 N (2500 lbf.) for one (1) minute. | PASS |
